BIRGE POND DAM

CT 00007

CONNECTICUT RIVER BASIN
BRISTOL, CONNECTICUT

PHASE I INSPECTION REPORT
NATIONAL DAM INSPECTION PROGRAM

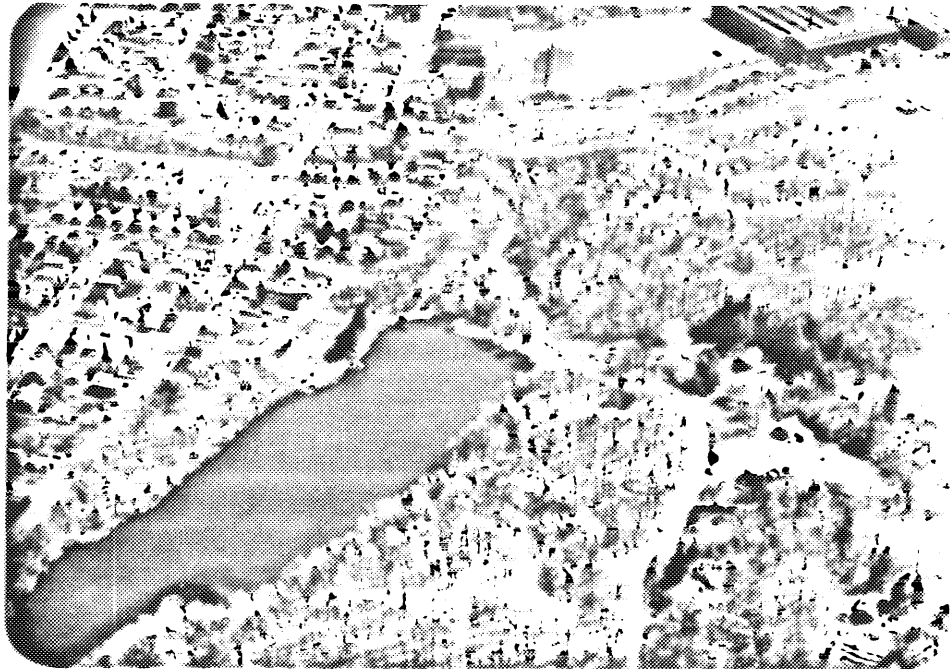
PHOTO NO. 1

OVERVIEW OF DAM
NOTE RAILROAD EMBANKMENT
DOWNSTREAM OF DAM.

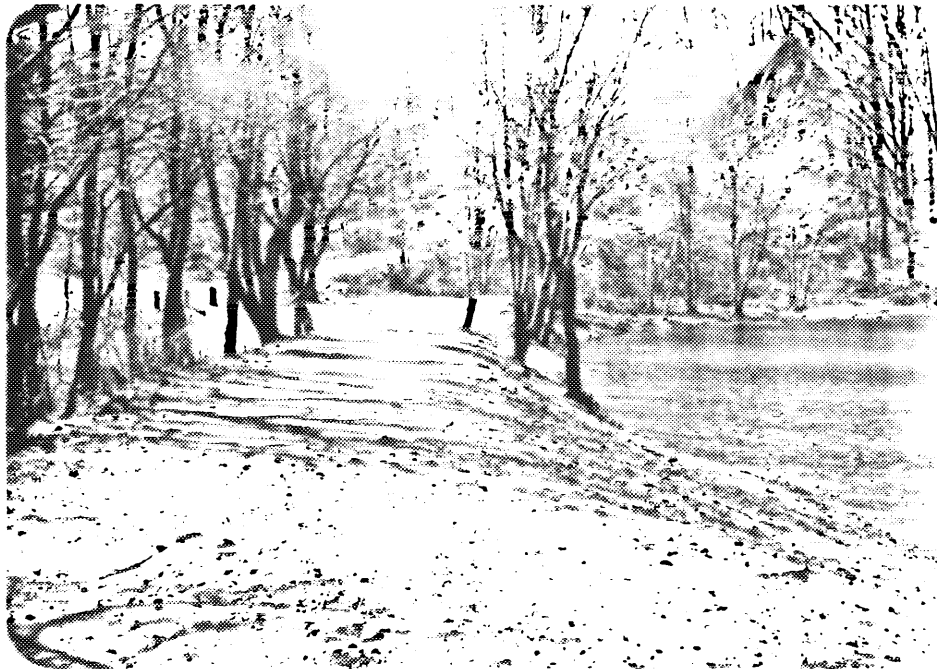
PHOTO NO. 2

The Birge Pond Dam consists of an earth embankment with a top width of 15 feet, a maximum height of 16 feet, an upstream slope of 2.5 horizontal to 1 vertical, and a downstream slope of 2.6 horizontal to 1 vertical. There are numerous trees growing from the upstream and downstream slopes of the embankment. The dam is 320 feet long, including a 57.3 foot long concrete overflow spillway located near the left end of the dam. The spillway was reportedly formed by constructing a reinforced concrete slab over the top of an existing earth and timber cribbing dam. The outlet works located at the left end of the dam consist of an upstream gatehouse and unknown piping which formerly supplied water to a downstream manufacturing plant.

DAM CREST FROM SPILLWAY.
NOTE TREES ON UPSTREAM AND DOWNSTREAM SLOPES
AND THE LACK OF UPSTREAM SLOPE PROTECTION

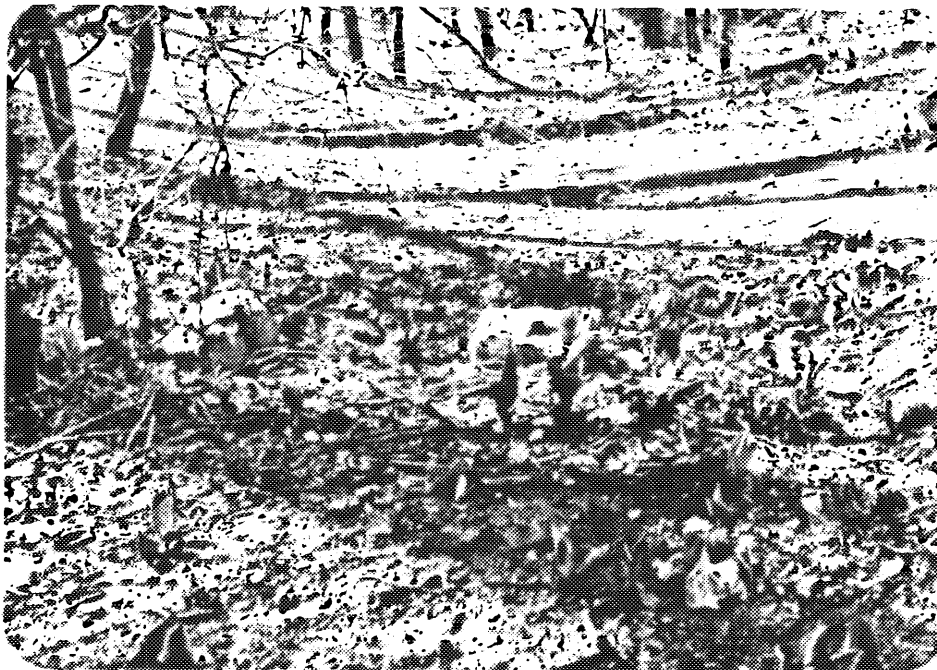
PHOTO NO. 3

SEEPAGE AREA NEAR TOE OF DAM

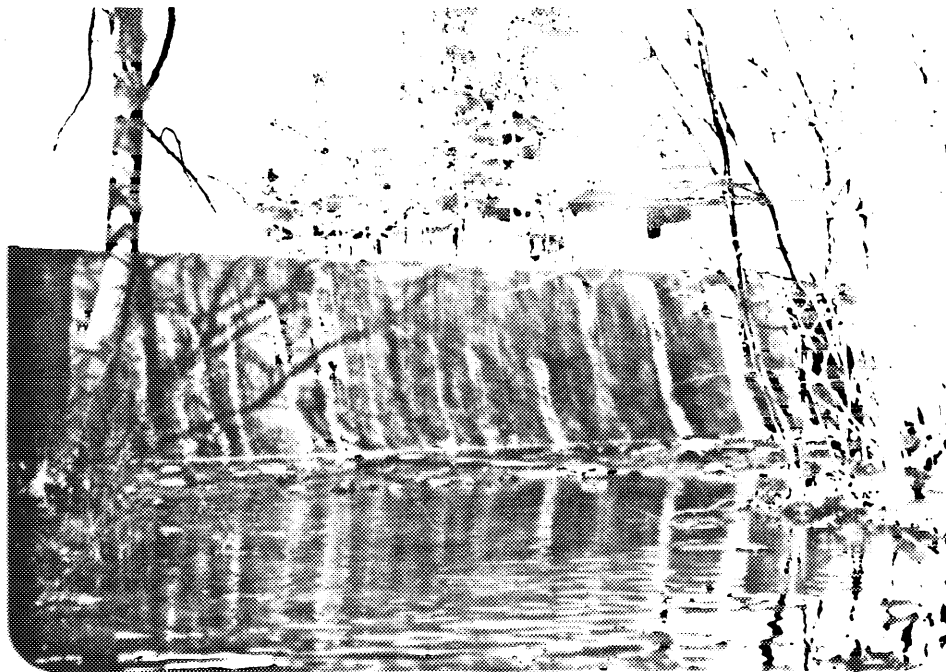
PHOTO NO. 4

SPILLWAY FROM DOWNSTREAM

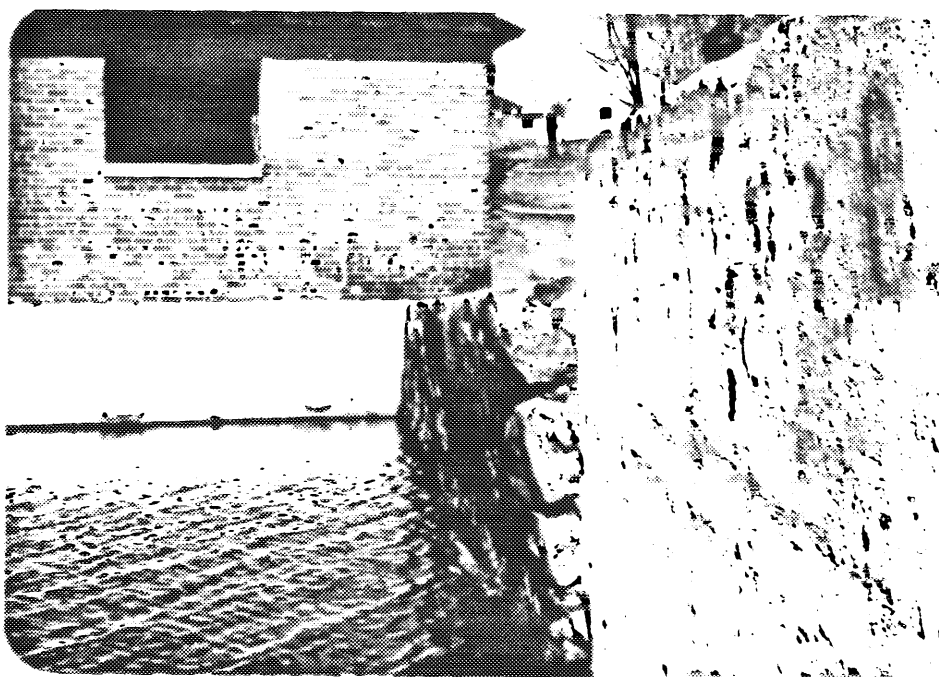
PHOTO NO. 5

STONE MASONRY WALL BETWEEN GATEHOUSE
AND LEFT SPILLWAY WALL. NOTE OUTWARD
MOVEMENT OF TOP OF WALL.

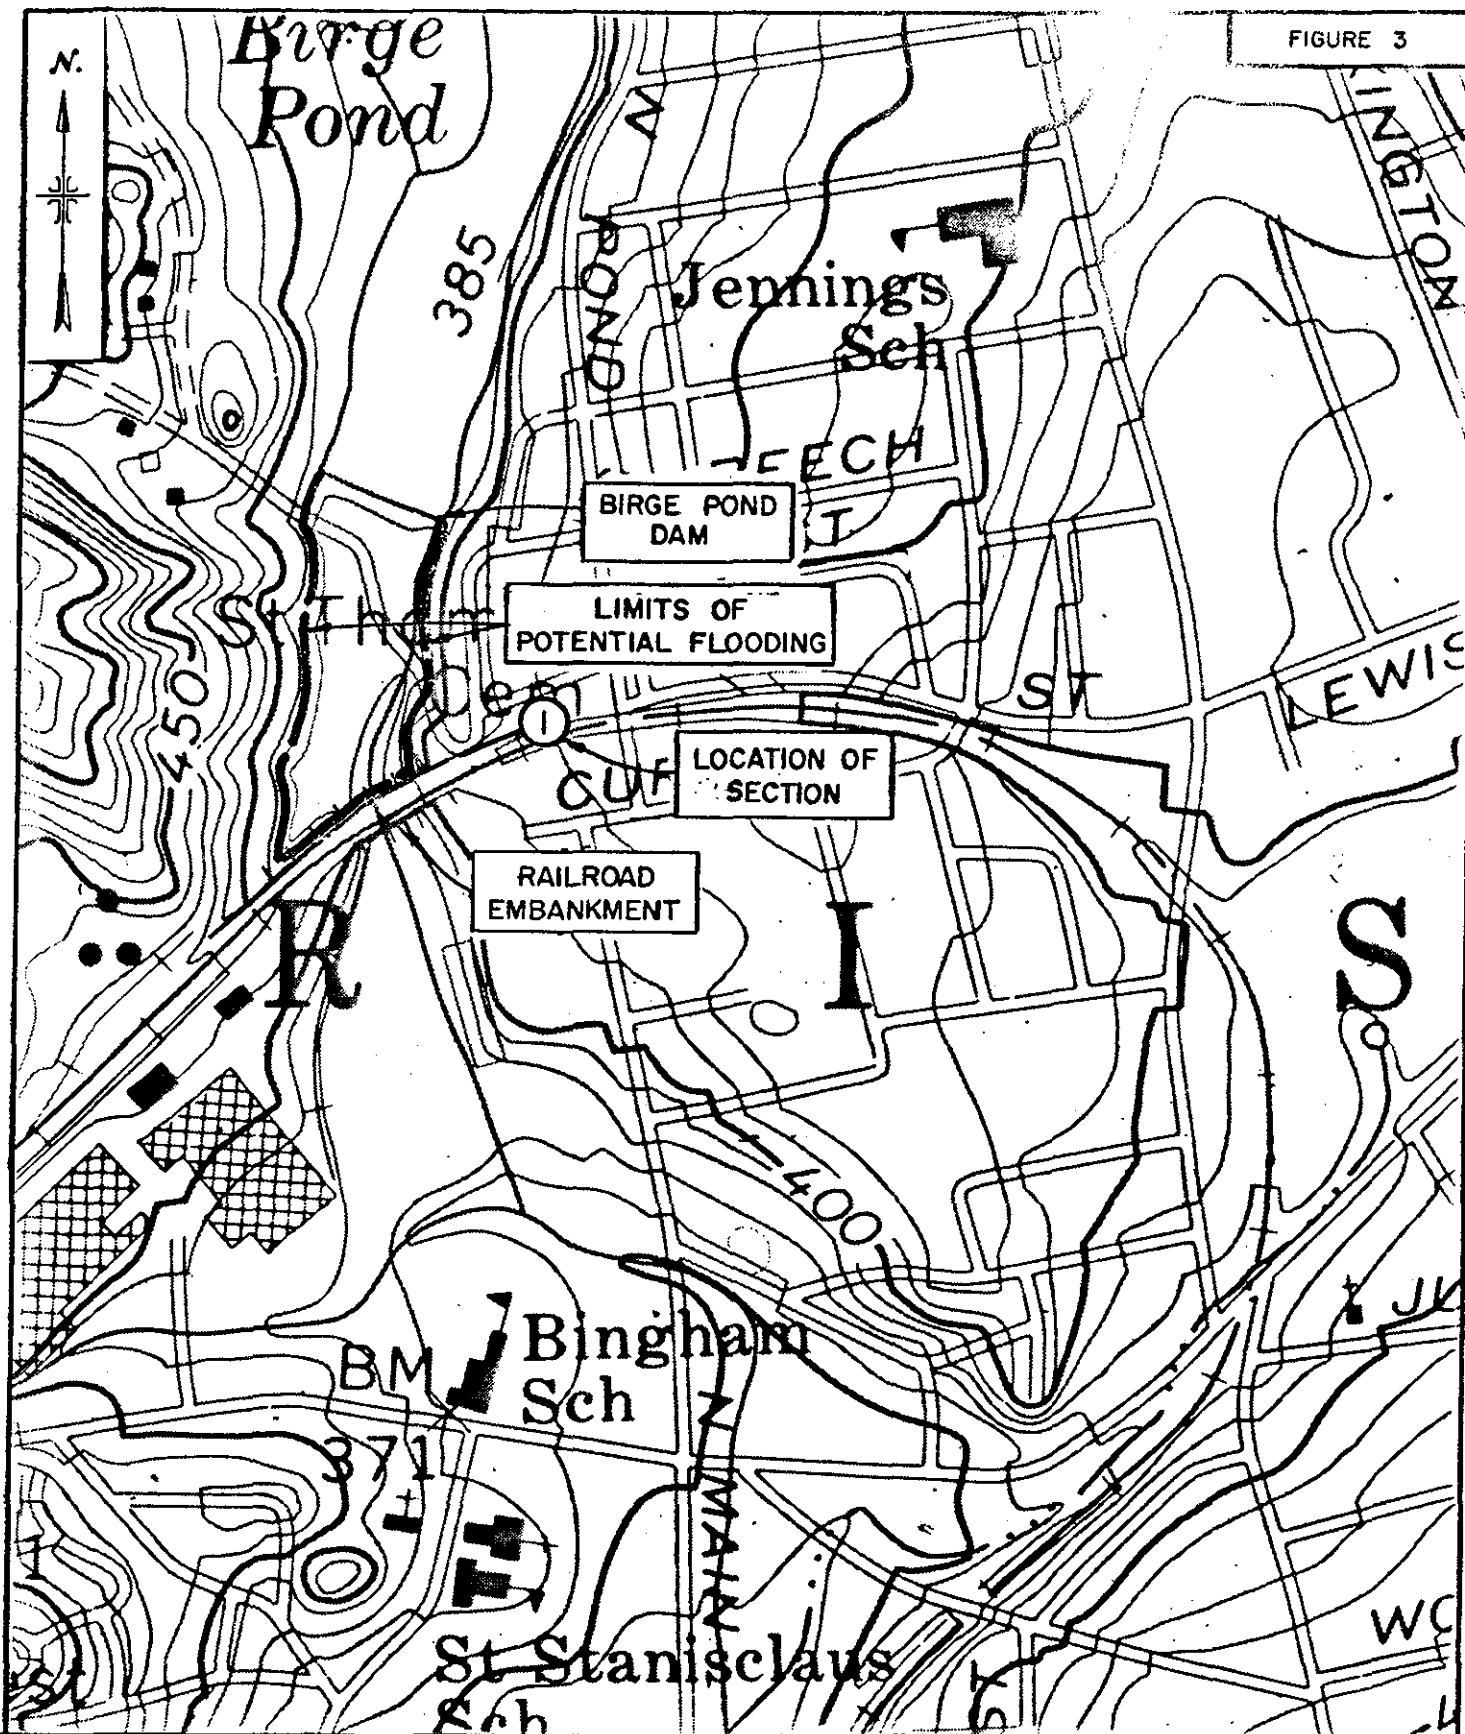
FIGURE 3

The flood waters would travel 800 feet downstream to a railroad embankment. The embankment would restrict the flood flows and cause substantial ponding. The discharge through the railroad embankment would be controlled by a 7-foot diameter stone masonry culvert. Flood routing calculations at the railroad embankment indicate the water surface elevation after dam breach would be approximately at Elevation 385, equal to spillway level. The top of the railroad embankment is about Elevation 400. The maximum outflow from the culvert, with the water level at Elevation 385, would be about 700 cfs.

Downstream culverts have a capacity of 1080 cfs according to the Bristol City Engineer. The roadway approximately 200 feet downstream of the dam would be inundated by 15 feet of water and possibly washed out. It is doubtful the railroad embankment would be damaged as a result of the dam breach.

No homes are located within the potential limits of a dam breach flood, therefore, the loss of any lives is unlikely. The dam is classified as "Low" Hazard Potential in accordance with the Corps of Engineers' Recommended Guidelines for Safety Inspection of Dams.

LIMITS OF POTENTIAL FLOODING
